Panama large pelagics longline FIP (Marpesca) Vessel visit

FIP vessel checklist

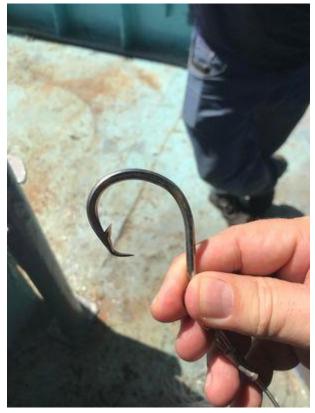
Figure 1: Photo of the regulation hooks used by the Marpesca longline vessels, approved by ARAP

ARAP visit the vessels each time they are landing in port. This is to ensure that all practices are being adhered to: correct hook size, net size and mesh etc. They have taken a greater interest in the fisheries because of the European Union yellow card incident.

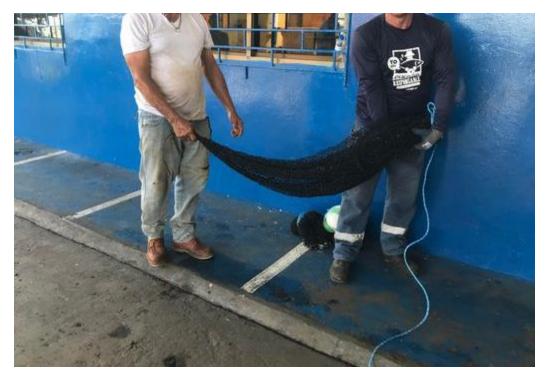
Figure 2: Photo of the sling net used to bring hooked ETP species, including sharks and turtles, onboard the vessel for safe and efficient hook removal

In the case of an ETP animal (shark or turtle) found hooked on the line, the crew use a custom-made sling net to scoop the animal out of the water, to avoid causing more injury to the individual via the hook, as well as to the fishers. This net was made by the fleet manager and uses thick netting material with a small mesh size. The sling is and has been used to catch sharks and turtles of different sizes and can withstand their weight. The sling is brought onto the deck and restricts the movement of the animal to avoid injury to itself and the crew. One crew member will retrieve the bolt cutters and cut the barbed section of the hook, so that the remaining hook can be released without inflicting more damage to the animal.

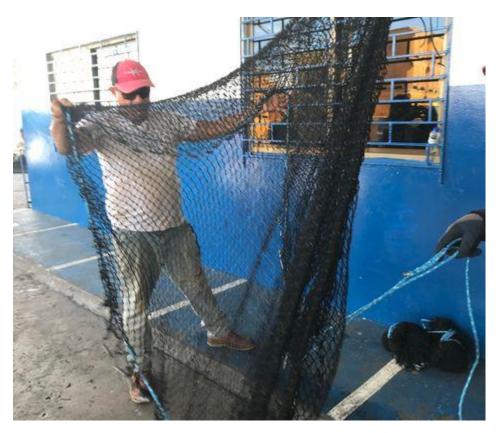
Figure 3: Another photo of the sling used to depict the size of the net
