Sea Trial 2022 05 29-31

Testing four different weakened buoy lines during normal snow crab fishing

(May 29-31, 2022)
Vessel: Carlo G.
21050.0002

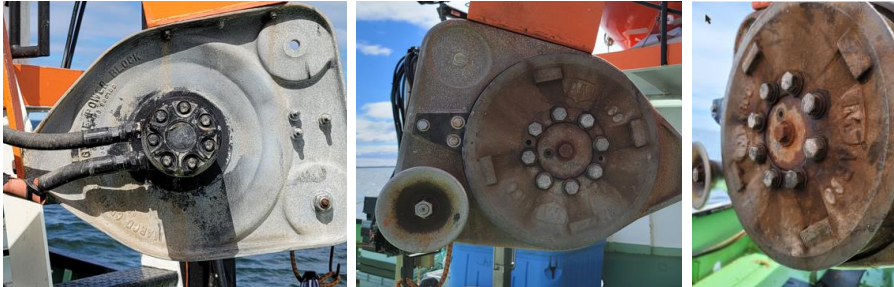
Figure 2: Hauler wheel configuration

- Hauler wheel: 15" OD, width 3/4 " ID.
- Condition: The inside of the two plates was smooth.

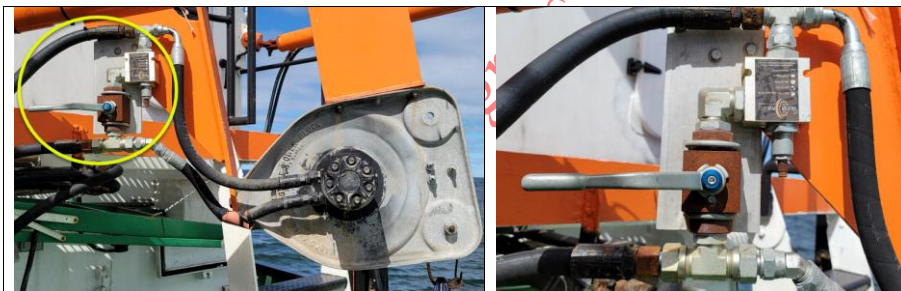
Figure 3: The hydraulic by-pass valve (Limiter) at left of the hauler wheel

- The limiter was installed in 2021 by Corbo and set at 1700 lbf.
- The limiter was switched on only during the hauling of the 4 weakened buoy lines
- Limiter was not calibrated in 2022.

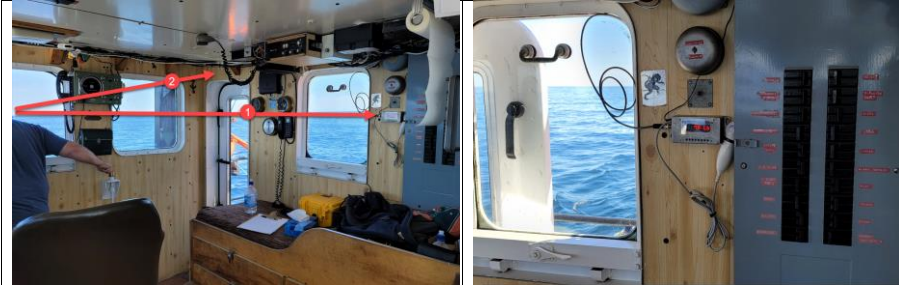
Figure 5: Tensiometer display meter is not aligned with the line of sight #1 of the operator

Two problems were observed in the pilot cabin. First, the “as shown” in Figure 5 the tensiometer display meter in the pilot house is not ideally located for a direct line of sight (#1) from the position of the operator of the control valve of the hauler wheel, i.e., the operator cannot view both the tensiometer display meter and the hauling operation without a significant movement of the head. In contrast, the proposed new location #2 would allow easier viewing of both the tension meter display and hauling operation, as suggested by line of sight #2.

5. that the tensiometer display meter in the pilot room be moved from the present wall location to the left side of the wall, in front of the captain line of sight

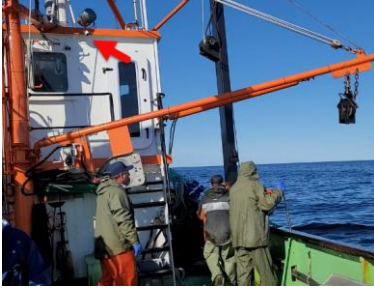
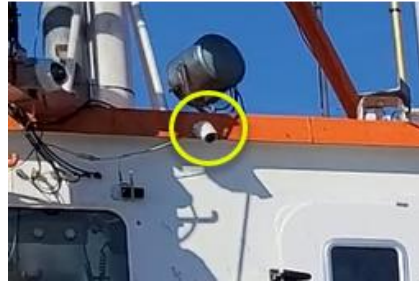
Figure 7: Location of the deck camera

Figure 7 shows the deck camera of the Carlo G installed by Corbo and located above and behind the hauler wheel at a distance of ~10'. Unfortunately, it was found after the fishing season that the camera was not recording!

6. that the onboard camera be checked to confirm that it is set to on.

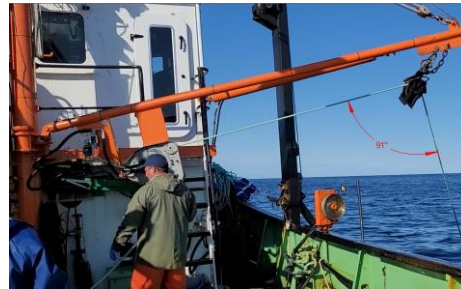
Figure 11: Included angle of two strings of the 5/8" traditional buoyline around the directional pulley

Included angles of the two strings of the buoyline around the hauler wheel were videotaped at least three times with a Samsung cell phone located perpendicular to the boom at a distance of about $2 f_a$ (**Erreur ! Source du r envoi introuvable.**). The first measurement was done at 08:26 (May 30th) and the last one completed at 08:42 am. Included angle measurements were conducted only with traditional buoy lines and determined with a protractor from various video frames (Figure 11).

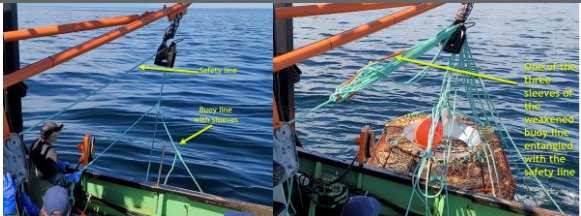
<p>Safety line hauled instead of the weakened buoy line with three 1-fa sleeves and line entanglement</p>
2

2. that, in future tension testing of weak ropes, the safety line be tied to a cement block tethered to the trap by a 75-fa rope, in order to shun its entanglement with the weakened buoyline being tested.

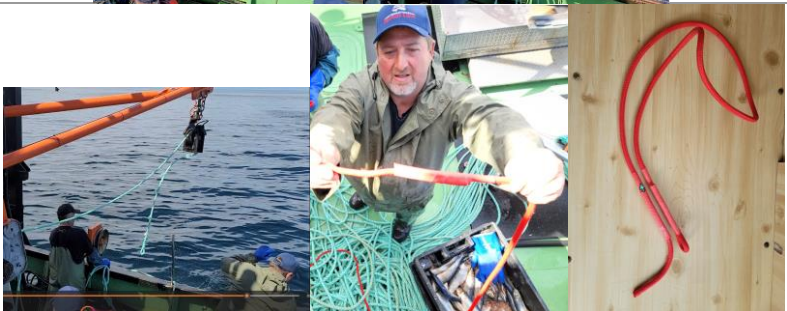
<p>At the 2nd 1-fa BreakAway release link in the weakened buoy line</p>

3. that the BreakAway release link be toughened up for condition at 4°C (breaking strength to be tested at 4°C) and retested
4. that a device be devised and tested to reduce the wear and tear of weak rope caused by the rubbing of a weakened buoy line against the side or underneath of the boat during hauling activities

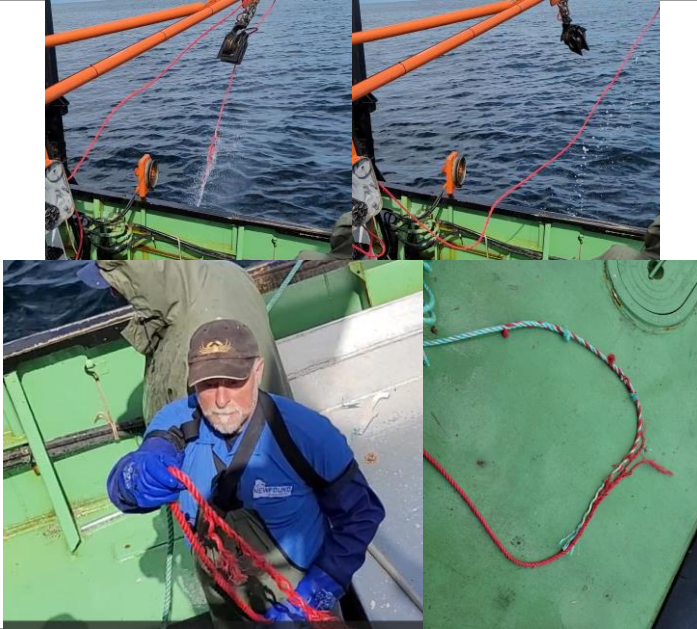
At the splice between the 37.5-fa weak red sinking rope and the 37.5-fa Polysteel sinking rope
